APD.MD.BF
CEILING/WALL ACCESS PANEL - METAL FACED WITH CONCEALED BEADED FRAME

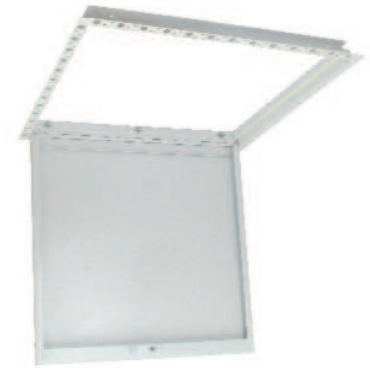
DESCRIPTION	Metal Door - Concealed Beaded Frame.
FIRE RATING	Non Fire - Rated, made from wholly non-combustible materials.
HINGE TYPE	Continuous Hinge.
COMPOSITION	Removable Flush Metal Faced Door. 1.2mm Thick Zintec Steel Perforated Frame. 0.9mm Thick Zintec Steel Door Tray. Polyester Powder Coated in matt white RAL 9010 20% gloss.
LOCKING	Budget Lock.
FITTING	Screw fix through the frame into a suitable trimming.
FRAME TYPE	Concealed Beaded frame for taping and skimming on site.

- Insert frame into structural opening which needs to be 5mm larger than panel size, ensuring frame is flush with surface. Then screw fix through fixing points using 5 x 16mm fixing screws. Additional packers may be needed to prevent distortion of the frame. DO NOT fix through the face of frame.

- Access Panels with a perforated frame are designed for a wet finish. Scrim tape must be applied to all beaded edges prior to plastering. IMPORTANT NOTE: If scrim tape is not used the plaster may not adhere to the access panel's frame.
